Infrared photos from water infiltration of Coffey Hall – August 23, 2006 - Room 90C

Coffey Hall August 23, 2004

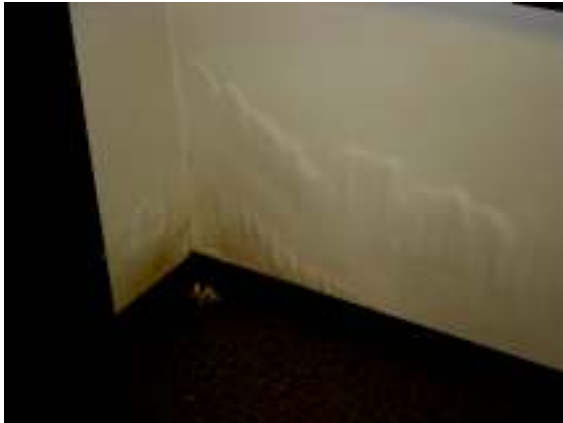
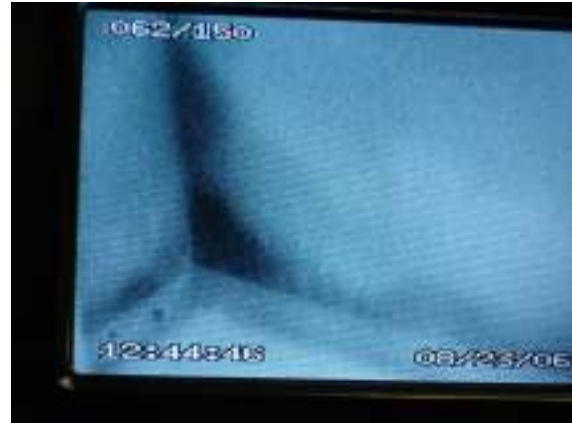
Room 90C Northwest corner – Area of water damage. The dark area on the IR photo has elevated moisture levels.

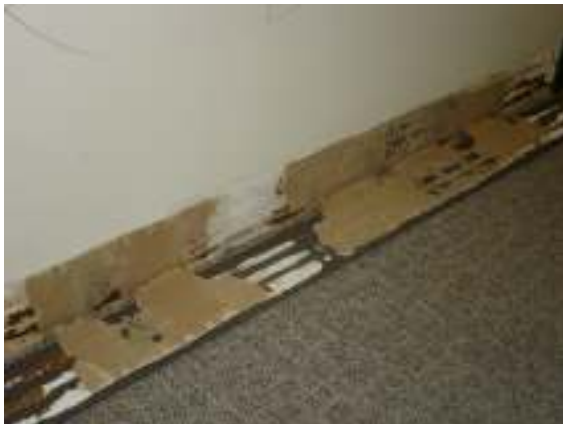
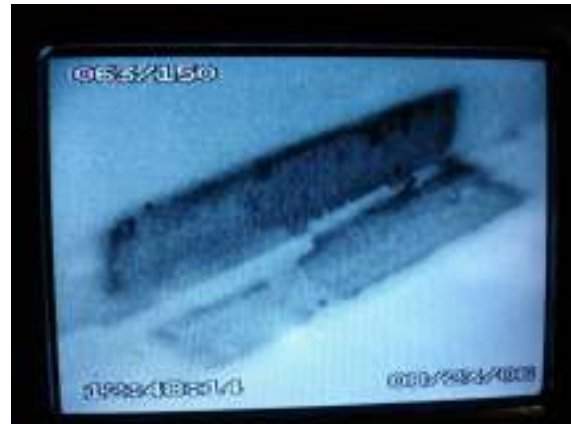
This is an area of fungal growth on the south wall of room 90 C. The Dark IR image on the left indicates an area of elevated moisture.

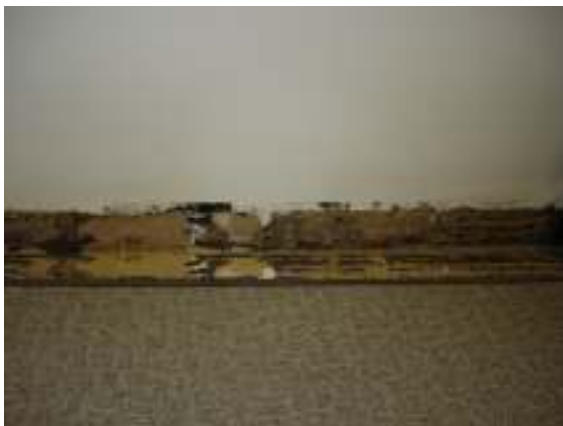
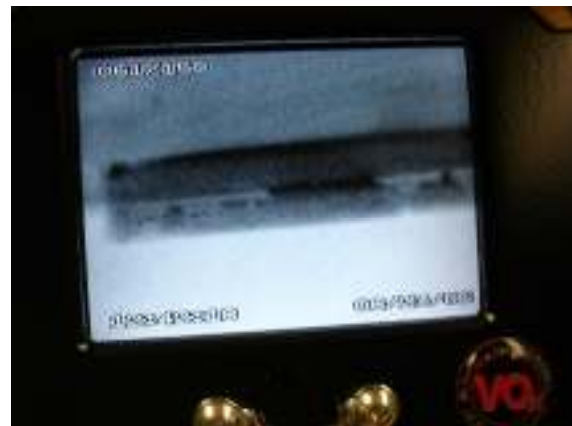
This is a photo of the west wall of room 90C showing an area of fungal growth. The Dark IR image on the left indicates an area of elevated moisture.

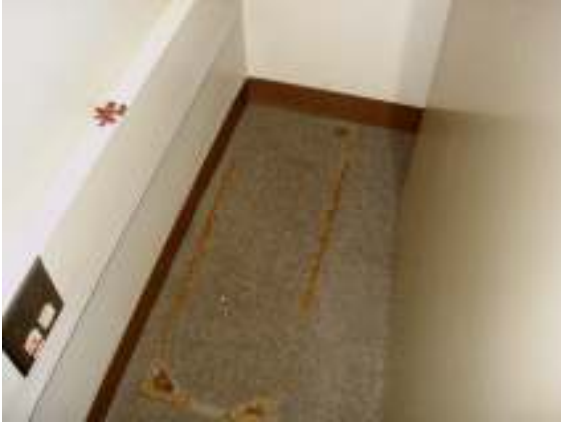
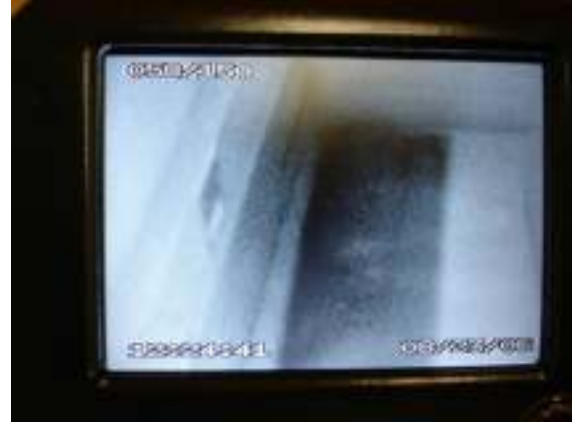
Room 90D Coffey hall northwest corner of room – infrared camera shot of location under cabinet. The wet carpet under the cabinet shows up as a dark image.

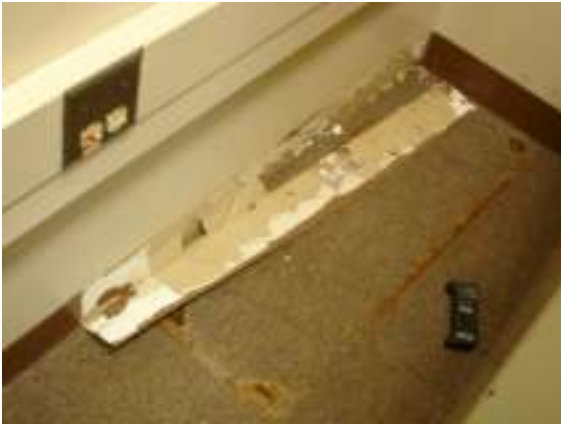
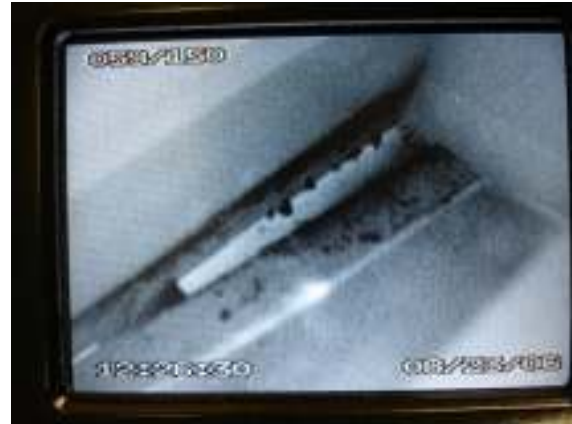
Base board West wall in 90 D – dark area IR photo has elevated moisture levels.
