Nils Hasselmo Hall – Stairwell pressurization fan

Sequence of events

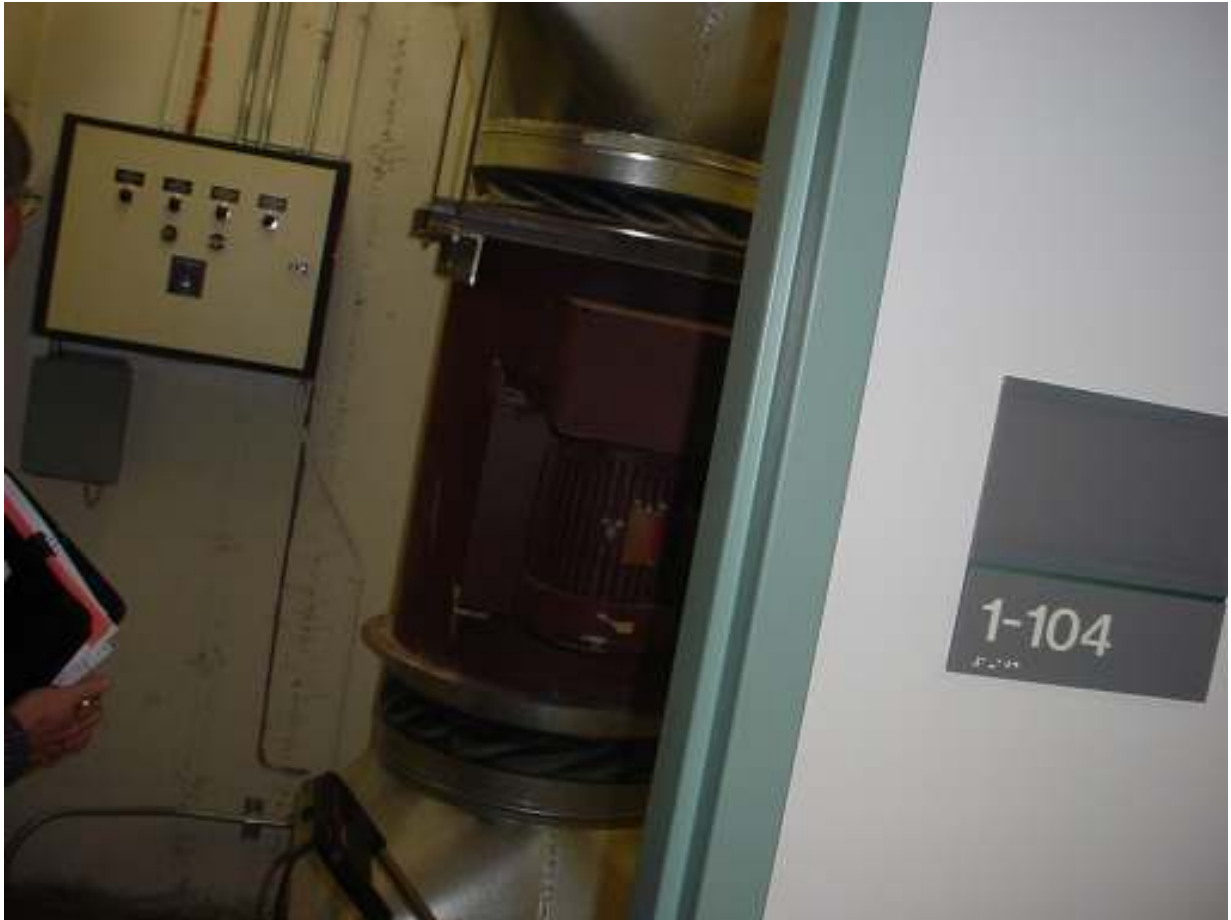
This fan pressurizes the stairwell with unconditioned air from the outside in the event of a fire to allow a smoke free evacuation route.

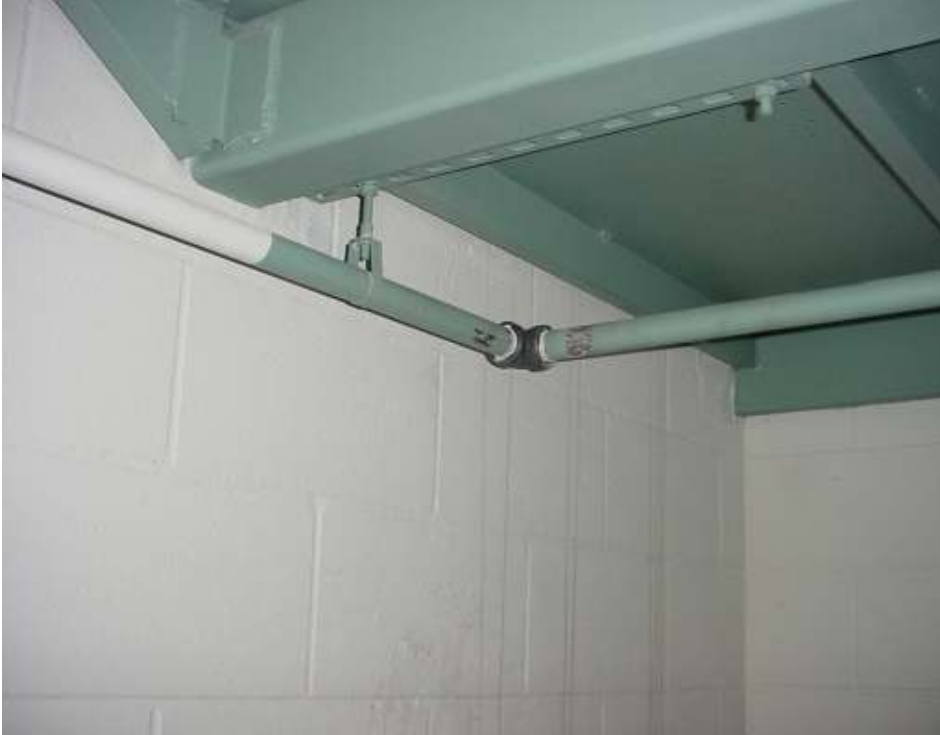
Location of pipe crack

- Stairwell pressurization fan on 5:30 pm Sunday
- Off by 9:30 pm Sunday
- BSAC reports a water flow alarm approx. midnight
- Pipe cracked then leaked when water in line froze and then melted
- Area has no floor drains
- Water stopped at approx. 2am.

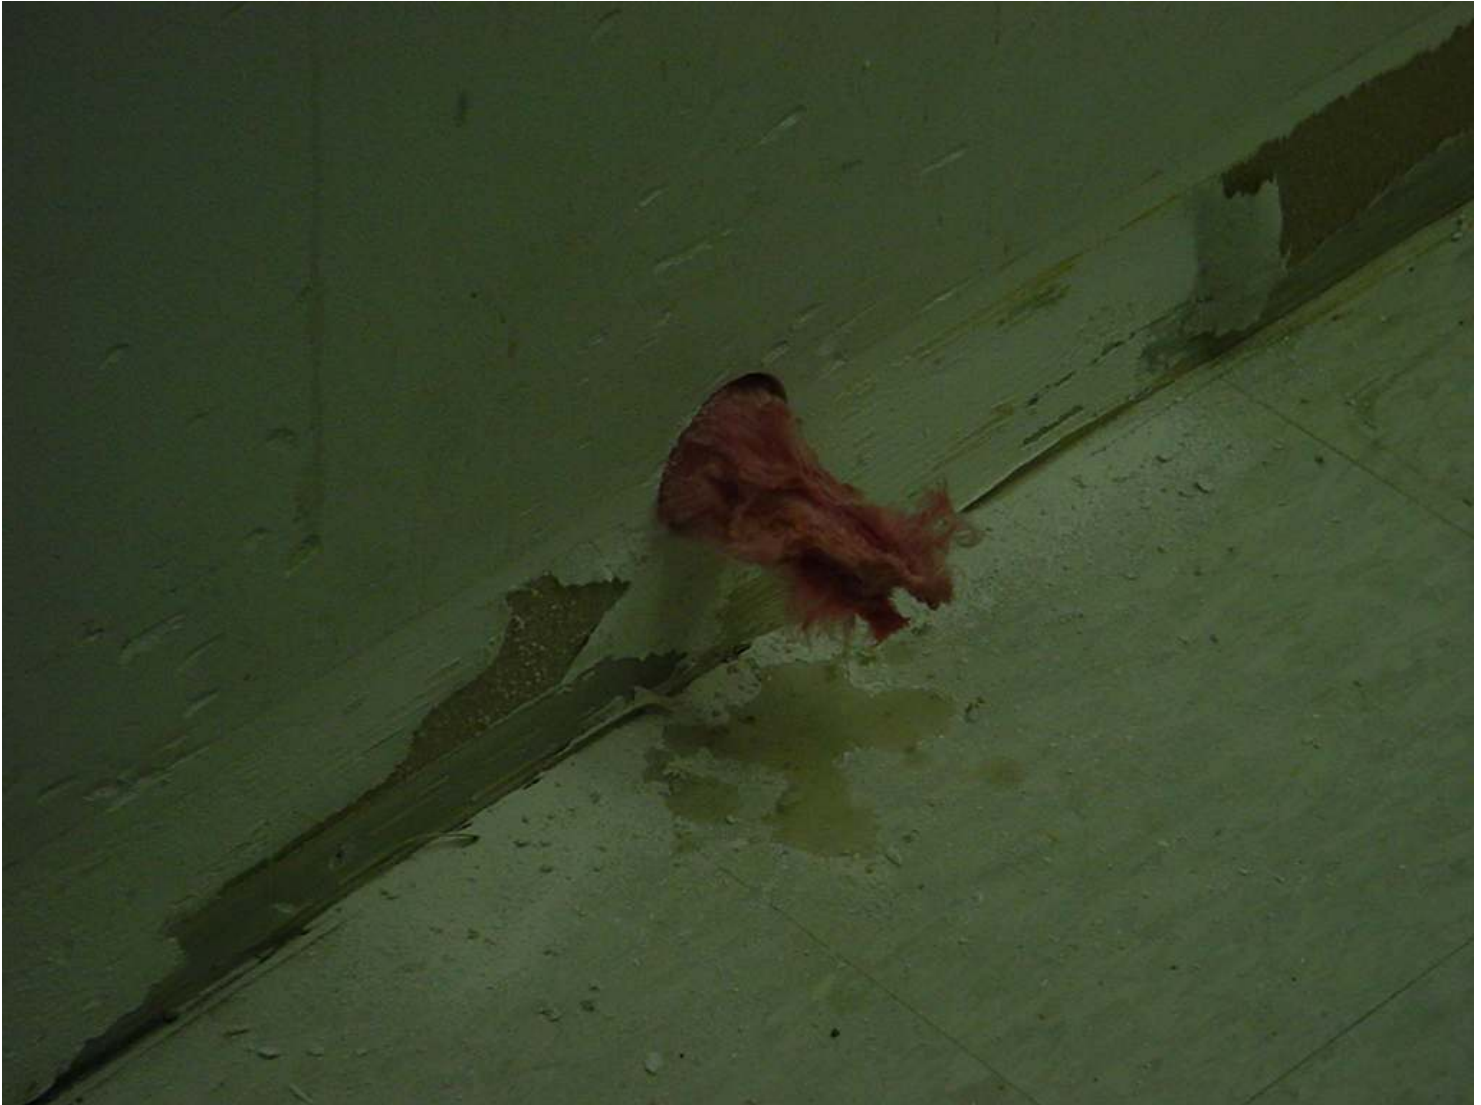
Wet insulation in water damaged wall 48 hours after flood.

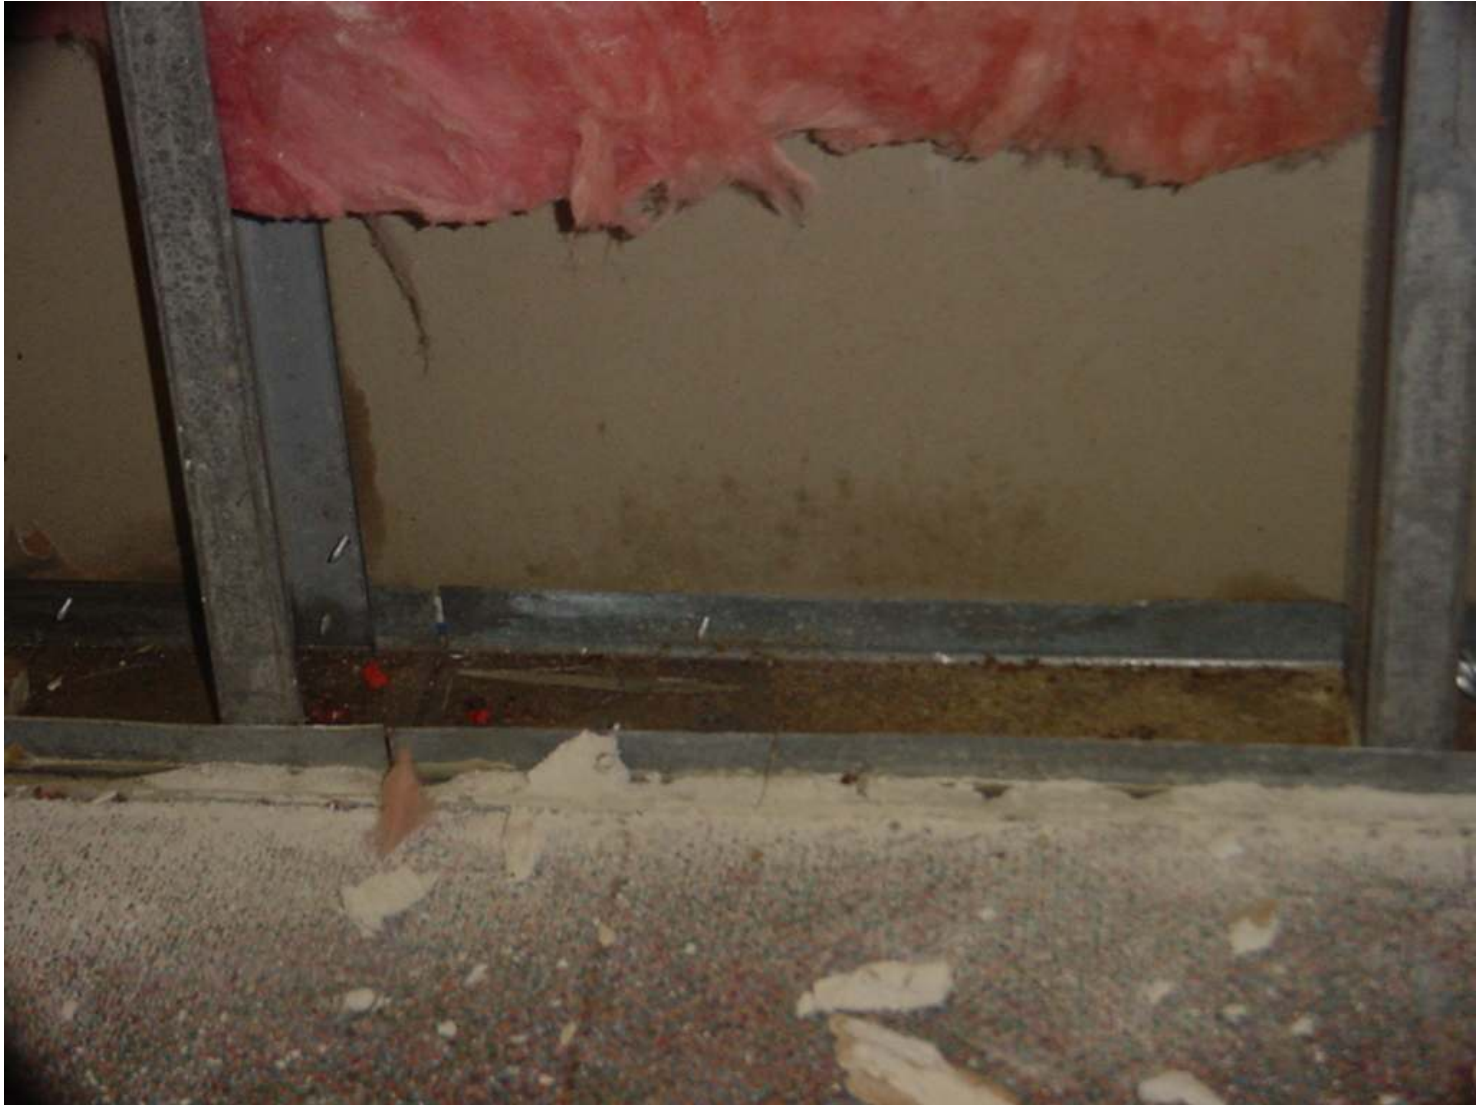
Mold growth less than 60 hours post flood

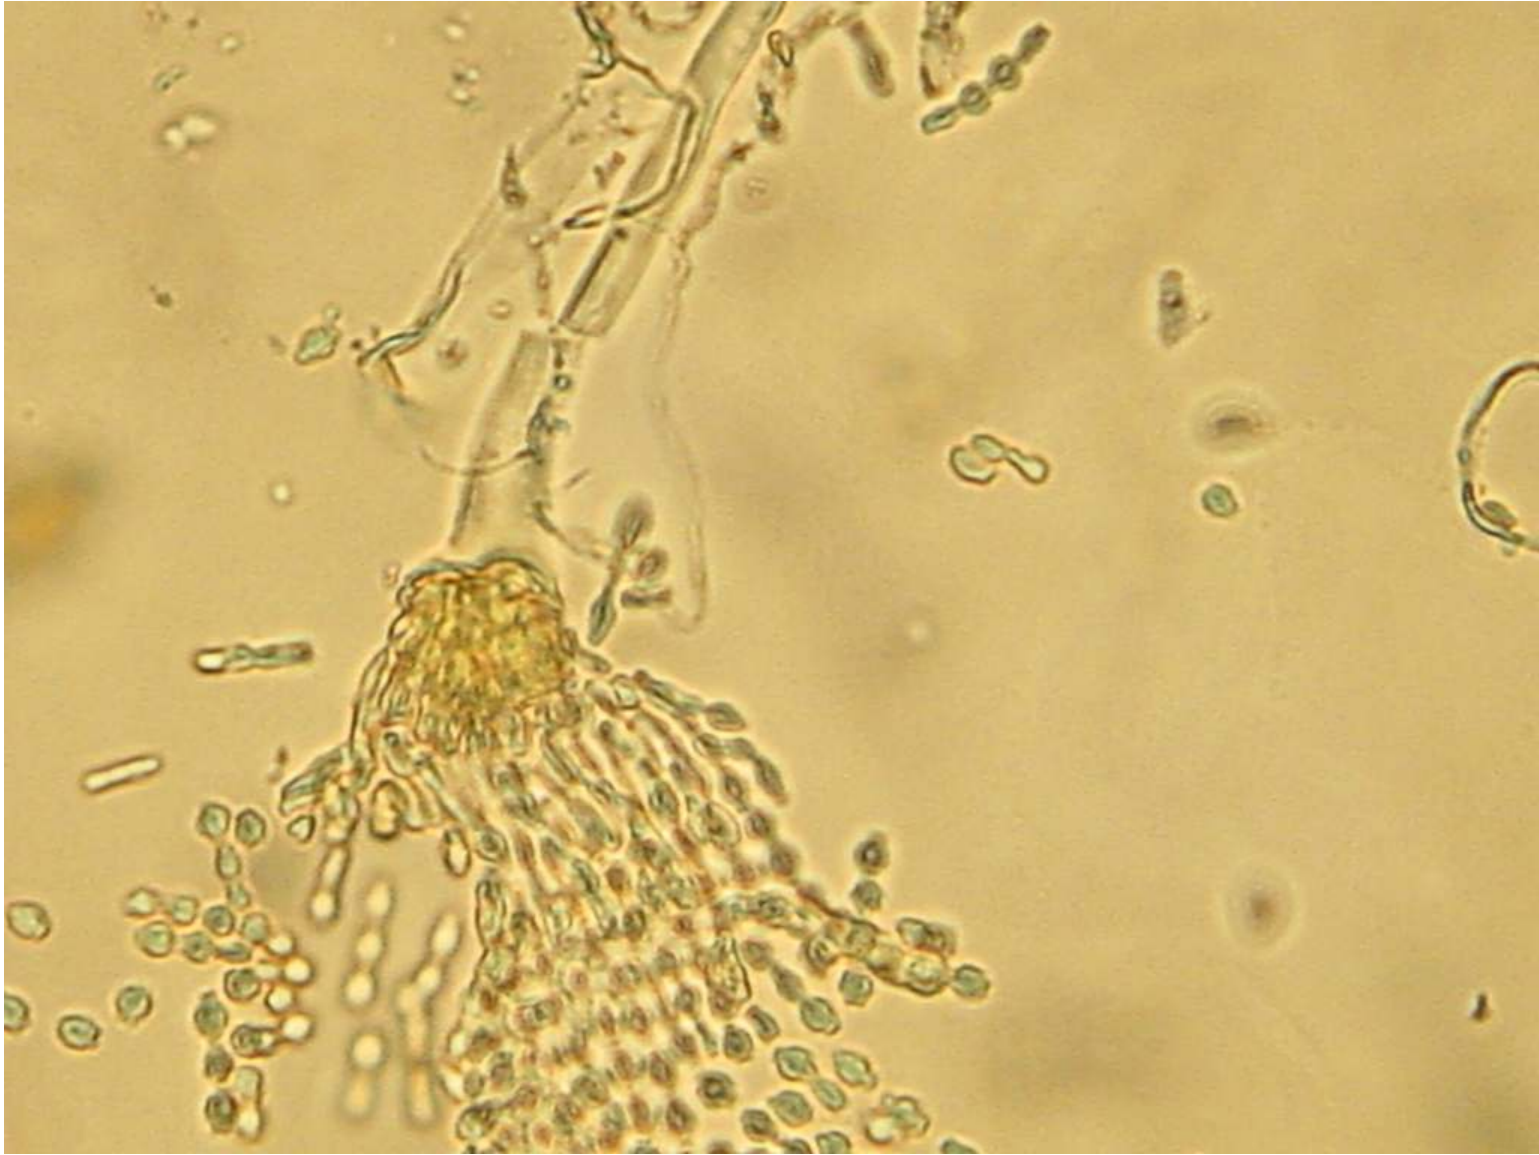
Microscopic photo of *Aspergillus spp.* growing on wall board (400x)
